US Army Corps  
of Engineers  
Fort Worth District

# Embankment Criteria, Performance, and Foundation Report

**Waco Lake  
Bosque River, Texas  
Brazos River and Tributaries, Texas**

January 1990

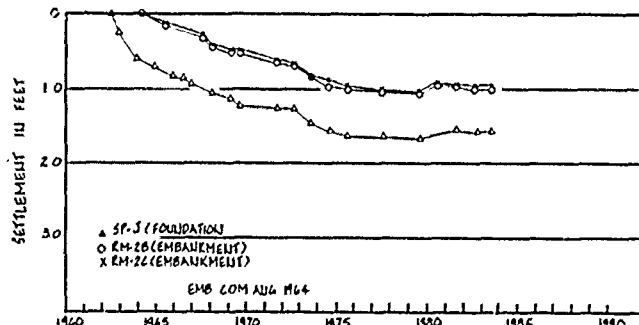
EMBANKMENT AND FOUNDATION  
SETTLEMENT  
STA 55+00, 300+5  
FIG. 4

NOTES:  
SETTLEMENT PLATE D IS SET ON TOP OF SHALE, EL. 395.7,  
SETTLEMENT PLATE K IS SET ON OVERBURDEN, EL. 408.0

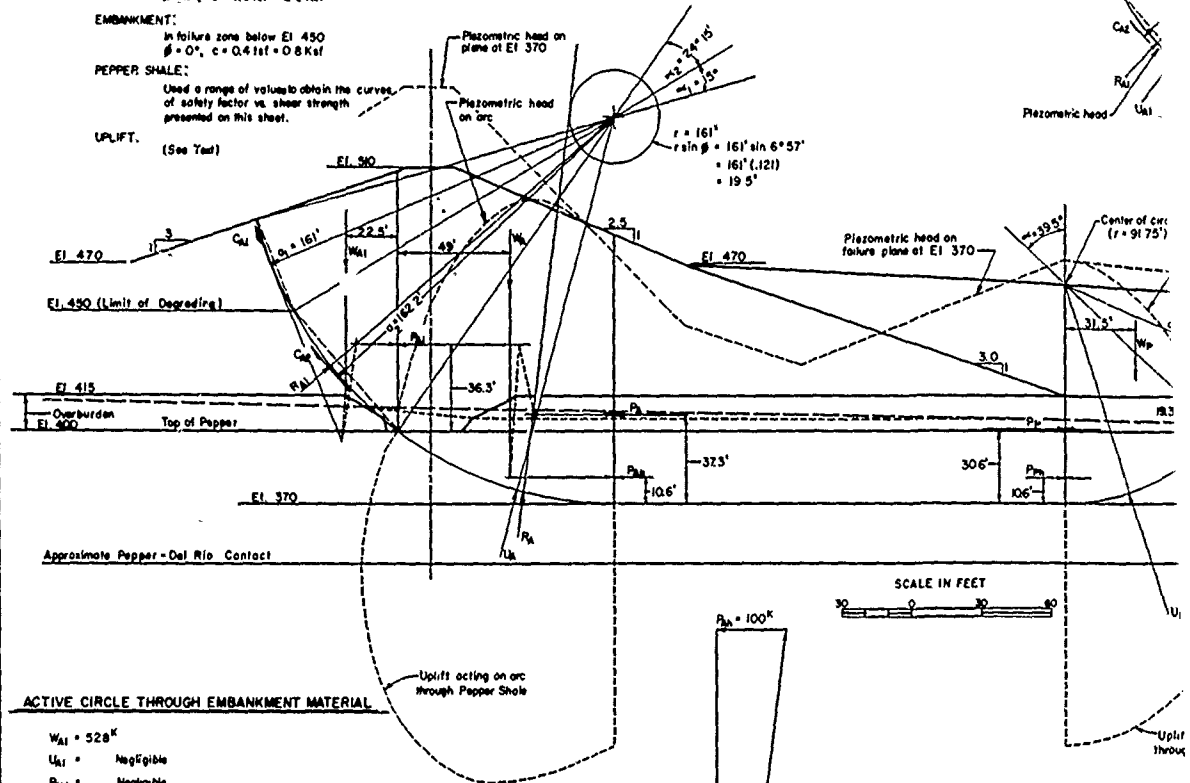
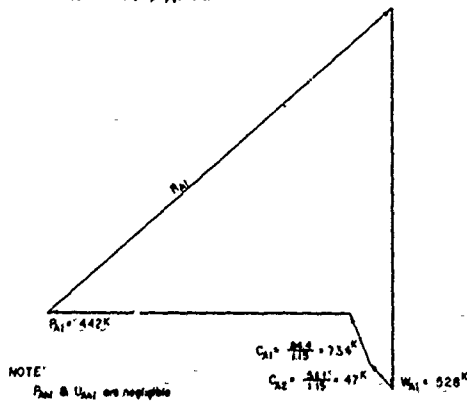
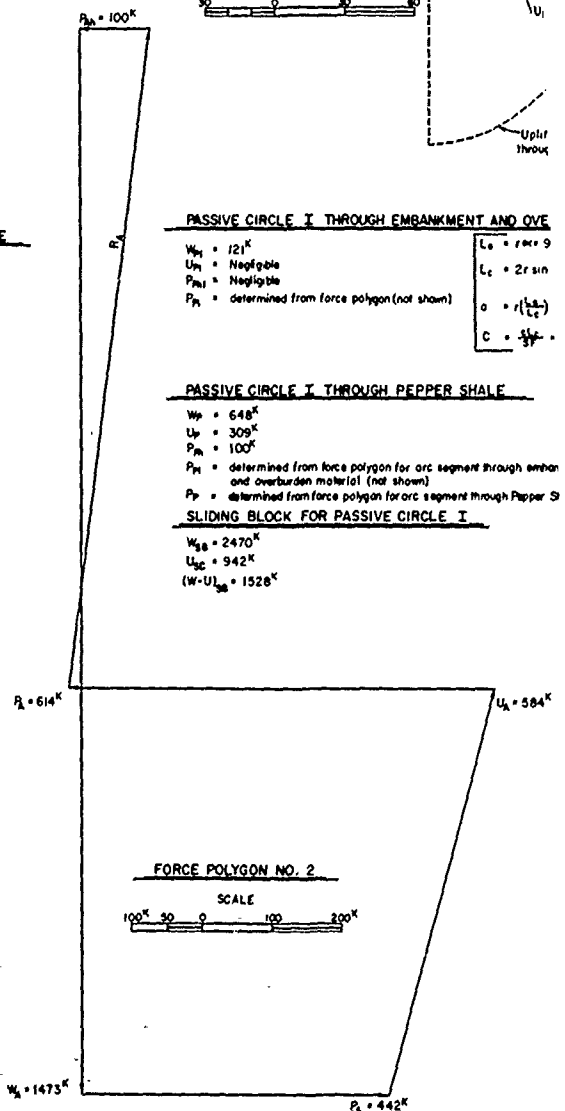
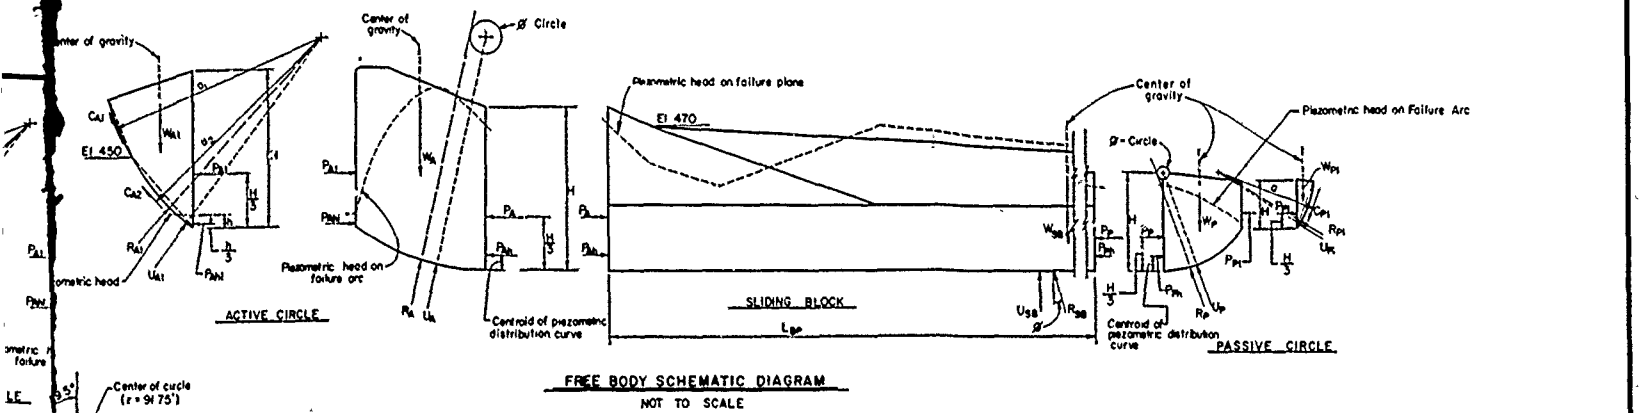
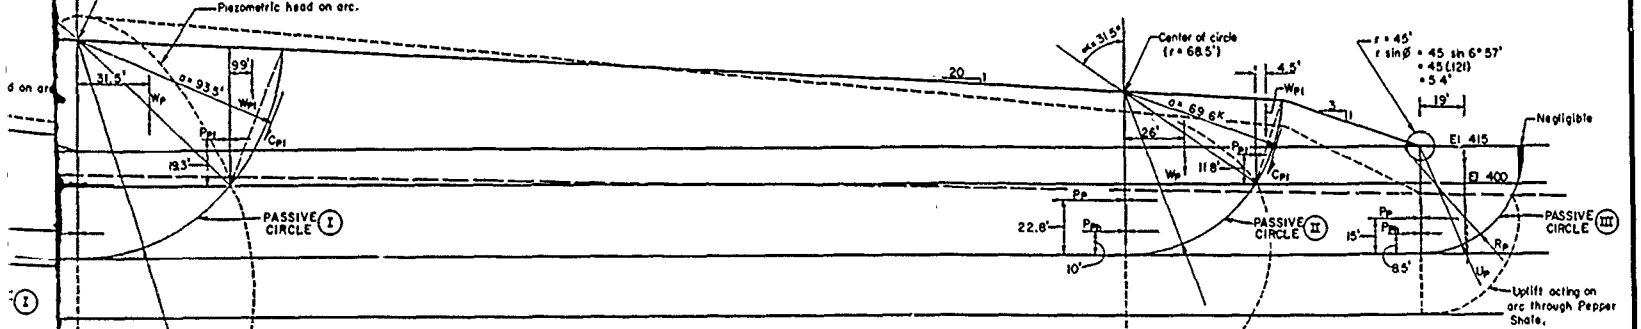
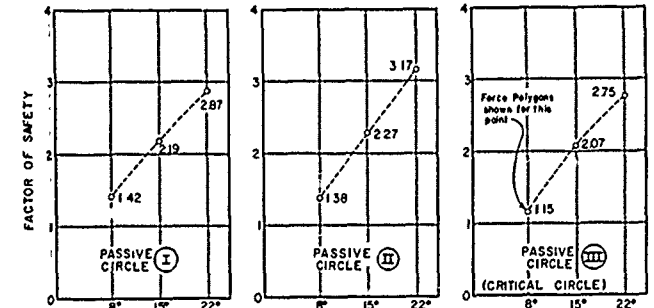
BRAZOS RIVER AND TRIBUTARIES, TEXAS  
 WACO DAM  
 BOSQUE RIVER, TEXAS  
**STABILITY ANALYSIS OF REPAIR SECTION**  
 FOR EXPECTED PORE PRESSURES  
 PHI - CIRCLE METHOD  
 EMBANKMENT SLIDE AREA - STATION 55+00  
 SCALES AS SHOWN  
 U.S. ARMY ENGINEER DISTRICT, FORT WORTH JAN. 1963

In failure zone below El. 450  
 $\phi = 0^\circ$ ,  $c = 0.4 \text{ tsf} = 0.8 \text{ Ksf}$

$W_p = 429^k$   
 $U_p = 154^k$   
 $P_p = 113^k$   
 $P_p$  = determined from force polygon for arc segment through embankment and overburden material (not shown)  
 $P_p$  = determined from force polygon for arc segment through Pepper Shale (not shown)

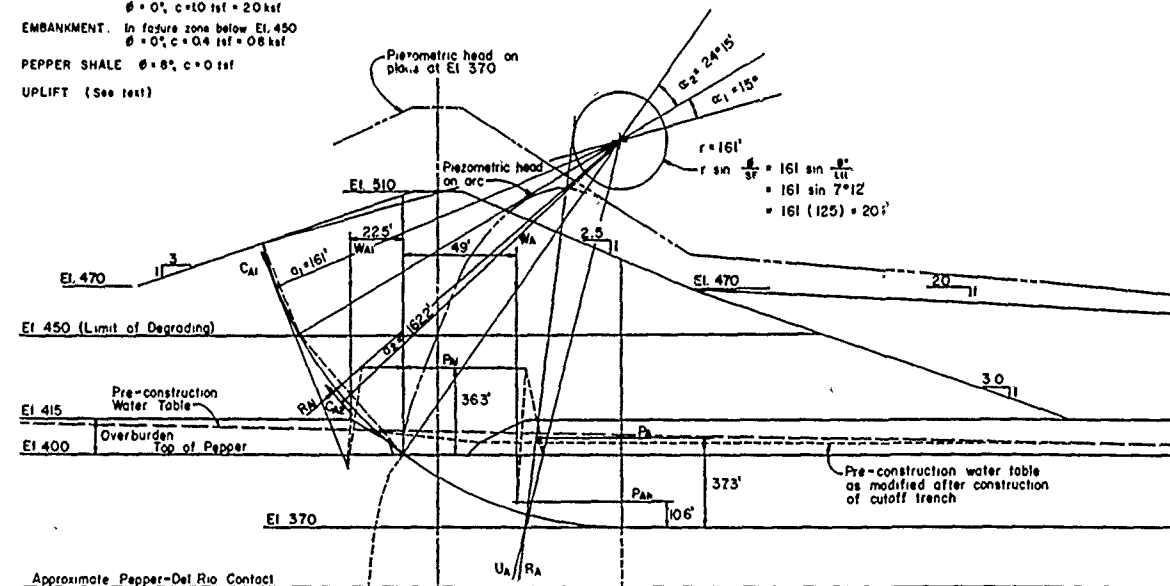
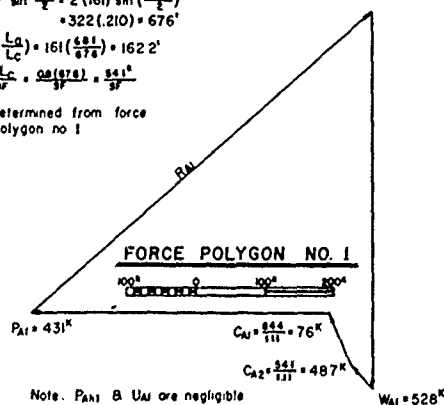
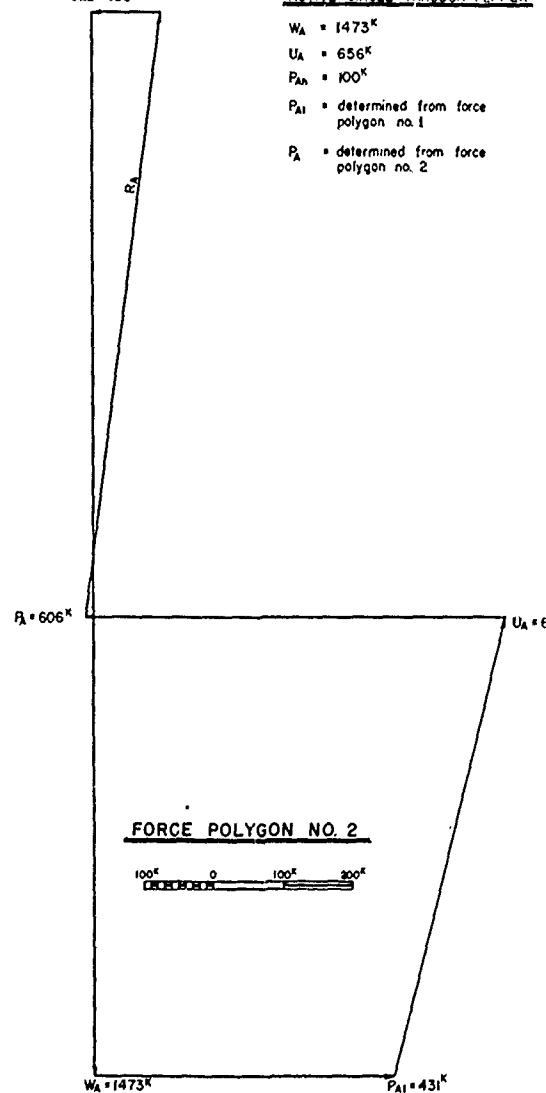
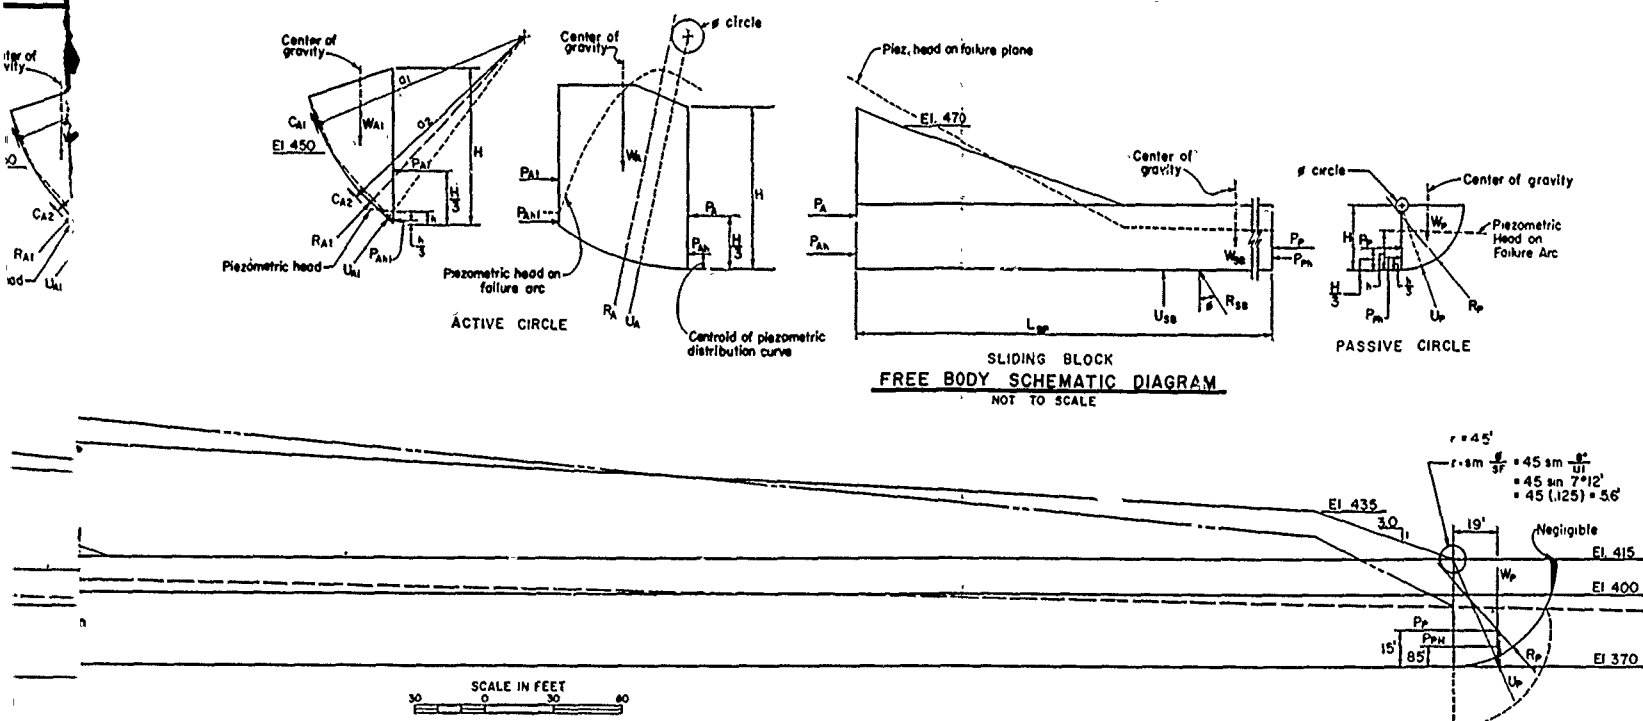
EMBANKMENT: In failure zone below El. 450  
 $\phi = 0^\circ$ ,  $c = 0.4 \text{ tsf} = 0.8 \text{ ksf}$

PEPPER SHALE  $\phi = 8^\circ$ ,  $c = 0 \text{ tsf}$

1. The slide was analyzed by a simplified procedure for a circular arc plane failure surface to determine the shear strength required for stability ( $sf=1.0$ ). The shear strength thus determined was applied to the repair section using comparable pore pressure assumptions to determine the safety factor.

2. The slide was analyzed for three elevations for the top of fill to show variation of strength required as construction of fill progressed. The results are summarized in Figure 1. The pore pressures used are identified as line series 1, 2, and 3. The repair section was analyzed using only the shear strength determined from the analysis of the slide with the fill at El. 497, and a safety factor = 1.72 was obtained.

3. The slide was analyzed using pore pressure line series 4, and the shear strength in the Pepper shale was determined to be  $\phi$  (effective) = 9.5 degrees. This value was applied to the repair section and a safety factor = 1.37 was obtained.

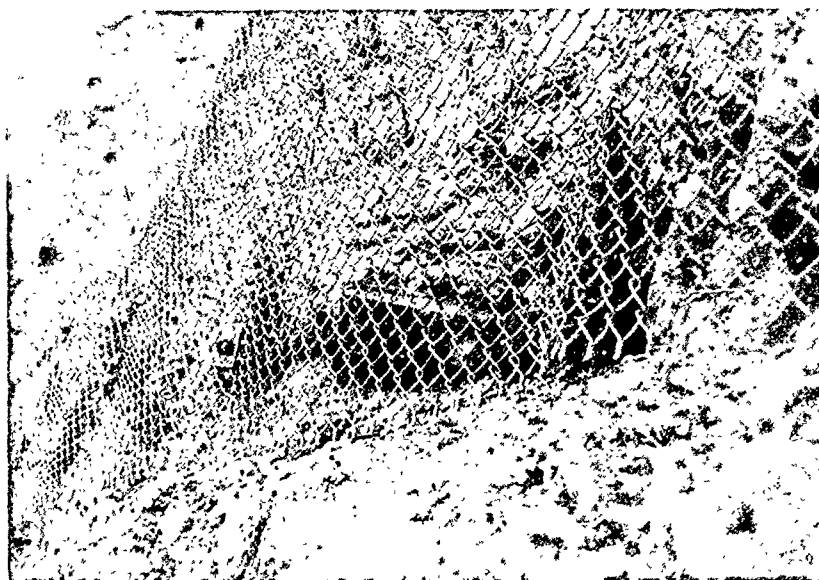
required only scaling and removal of minor overhangs (See Photos 26 and 27. On the side slopes, the loose material and overhangs were removed as much as practical, and the fill tamped in tight with hand equipment. The placement of rock bolts and protective wire mesh undoubtedly restricted the amount of sloughing, and only minor quantities of loose chalk occurred under the mesh. Very little of the mesh stretched or tightened during the time it was in place. All mesh and bolts were removed or cut as the fill was brought up.

PHOTO 27. Rock bolts and protective wire mesh,  
Feb 64
